FAILURE OF UNS N10276 REACTOR IN SUPERCRITICAL WATER SERVICE

D. W. Alley, S. A. Bradley
UOP
25 E. Algonquin Rd.
Des Plaines IL 60017

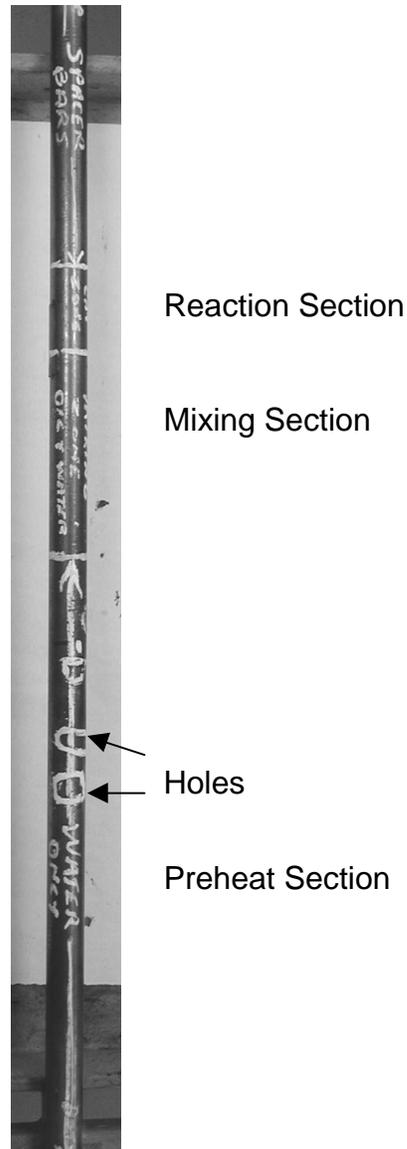
The reactor was received with the location of the holes detected via the pressure test marked. As shown in Figure 2, the locations of the preheat zone (labeled water only), the mixing zone, and the reaction zone were marked to orient the remainder of the investigation. As may be seen from this Figure, there is little evidence of corrosion from the outside of the reactor.

Figure 2 Photo of exterior of reactor. Location of holes detected by pressure test as well as preheat (water only), mixing and reaction zones are marked.

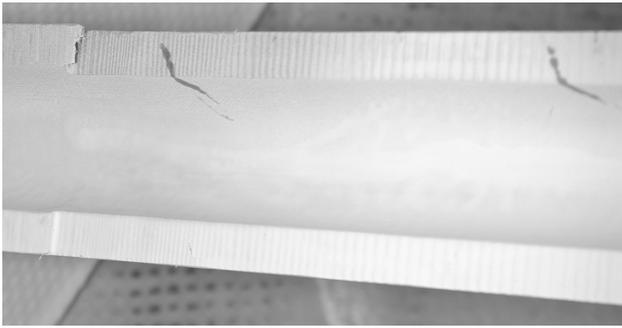
Following the external visual examination, the reactor was sectioned longitudinally. One section was subjected to dye penetrant examination. Dye penetrant revealed several cracks in the preheat zone and no cracks in the mixing or other zones. Some of the preheat zone cracks on the ID of the reactor are shown in Figure 3.

Figure 3 Photo of cracking on the ID of the reactor in the preheat zone revealed by dye penetrant examination

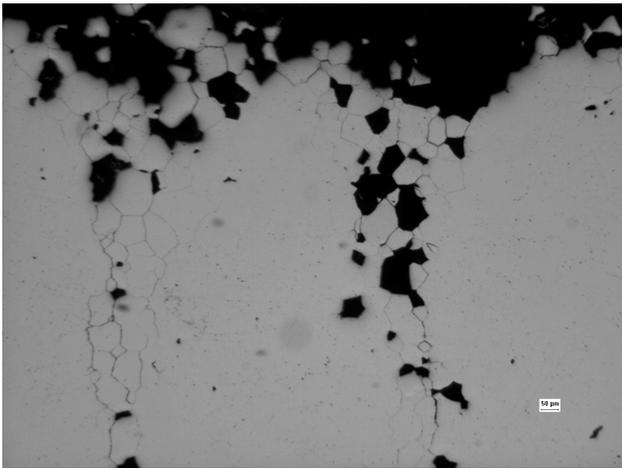
Figure 4 illustrates the condition of the inner surface of the alloy 276 reactor at the point of one of the through wall failures (approximately 8" below the mixing point.) Note the extensive intergranular corrosion.

Figure 4 Micrograph of reactor ID at location of failure (approx. 8" from mixing zone)

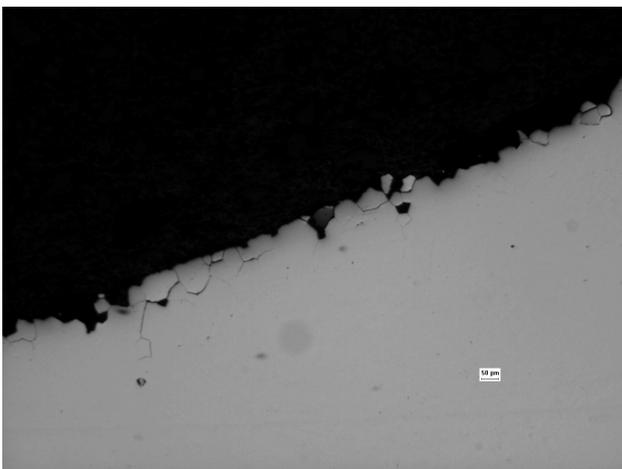
Figure 5 illustrates the inner surface of the alloy 276 reactor at the same distance from the mixing point as Figure 4. Figure 5 is located on the opposite inner surface (approximately 180° from Figure 4. Even though there is extensive intergranular attack in this Figure, it is far less than that in Figure 4.

Figure 5 Micrograph of reactor ID 180° from Figure 4 at same distance from mixing zone

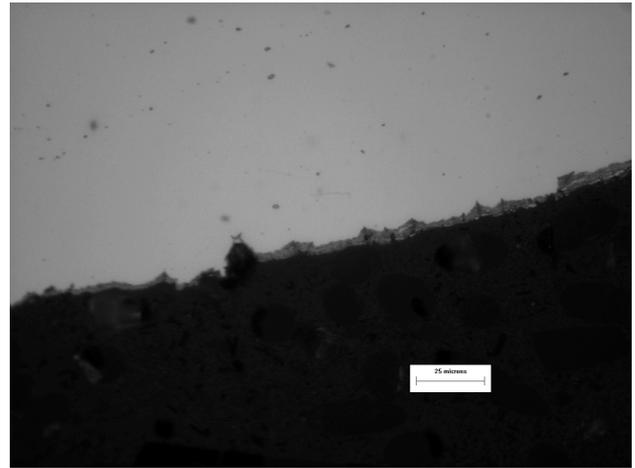
Figures 6 – 9 illustrate the condition of the outer surface of the dip tube (that exposed to the water) at 1, 3, 7, and 12 inches below the mixing point. Note the absence of significant intergranular attack in Figures 6 and 9, taken at 1 and 12 inches below the mixing point, and the significant attack shown in Figure 7 and 8 taken at 3 and 7 inches below the mixing point.

Figure 6 Micrograph of water side of dip tube 1" from mixing zone

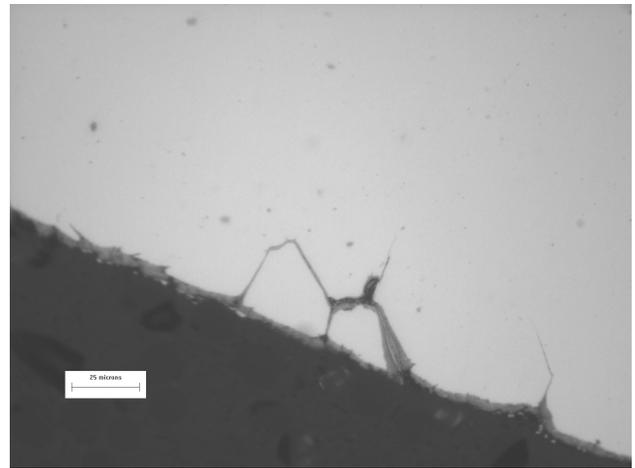
Figure 7 Micrograph of water side of dip tube 3" from mixing zone

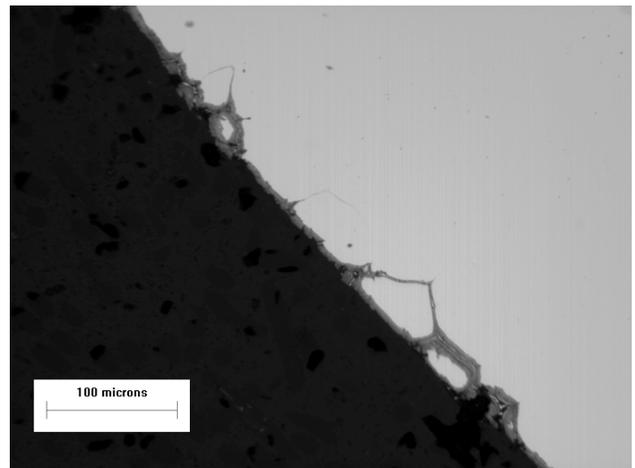
Figure 8 Micrograph of water side of dip tube 7" from mixing zone

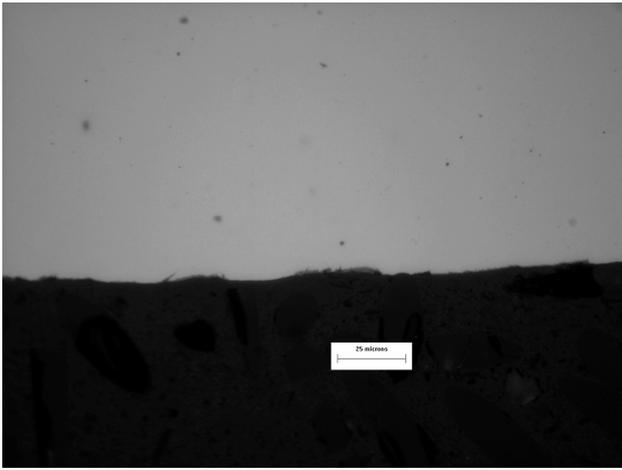
Figure 9 Micrograph of water side of dip tube 12" from mixing zone

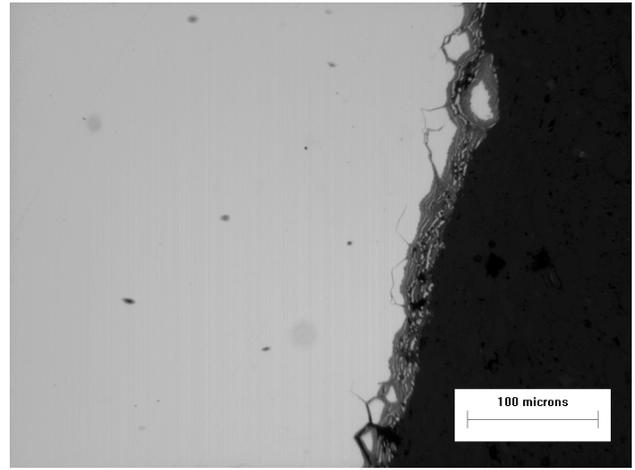
Figures 10 – 12 illustrate the condition of the tripod (type 316 stainless steel) at 3, 7, and 13 inches below the mixing point. Note that while all Figures show attack, the attack is substantially greater in Figure 11 which is at 7 inches below the mixing point.

Figure 12 Micrograph of tripod 13" from mixing zone

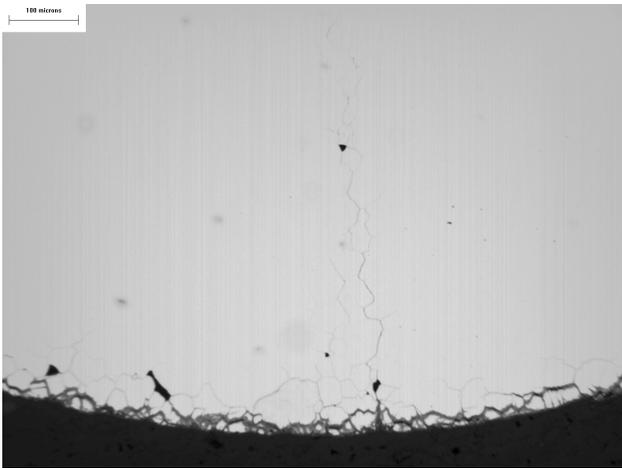
Figure 10 Micrograph of tripod 3.5" from mixing zone

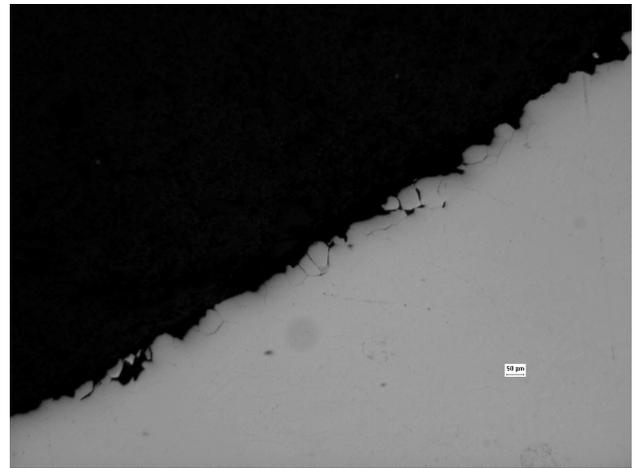
Figure 13 illustrates the condition of the inner surface of the reactor in the mixing zone. Note the presence of minor intergranular attack.

Figure 13 Micrograph of reactor ID in the mixing zone

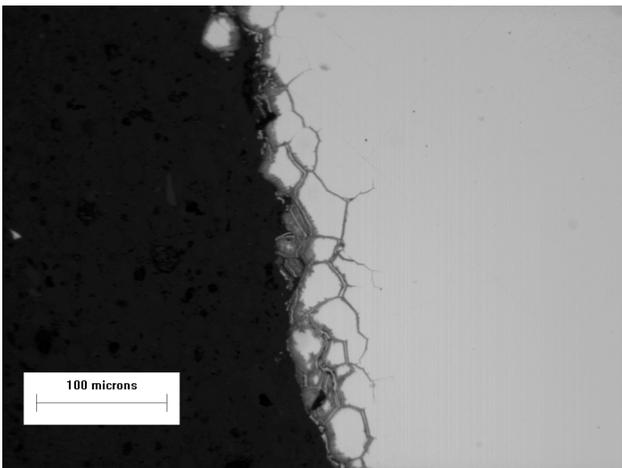
Figure 11 Micrograph of tripod 6.5" from mixing zone
