ANALYSIS OF A SEIZED CA6NM PLUG AND CAGE CONTROL VALVE IN HYDROPROCESSING SERVICE

D. W. Alley, S. A. Bradley and M. W. Mucek
UOP LLC.
25 E. Algonquin Rd.
Des Plaines IL 60017
e-mail: david.alley@uop.com

ABSTRACT

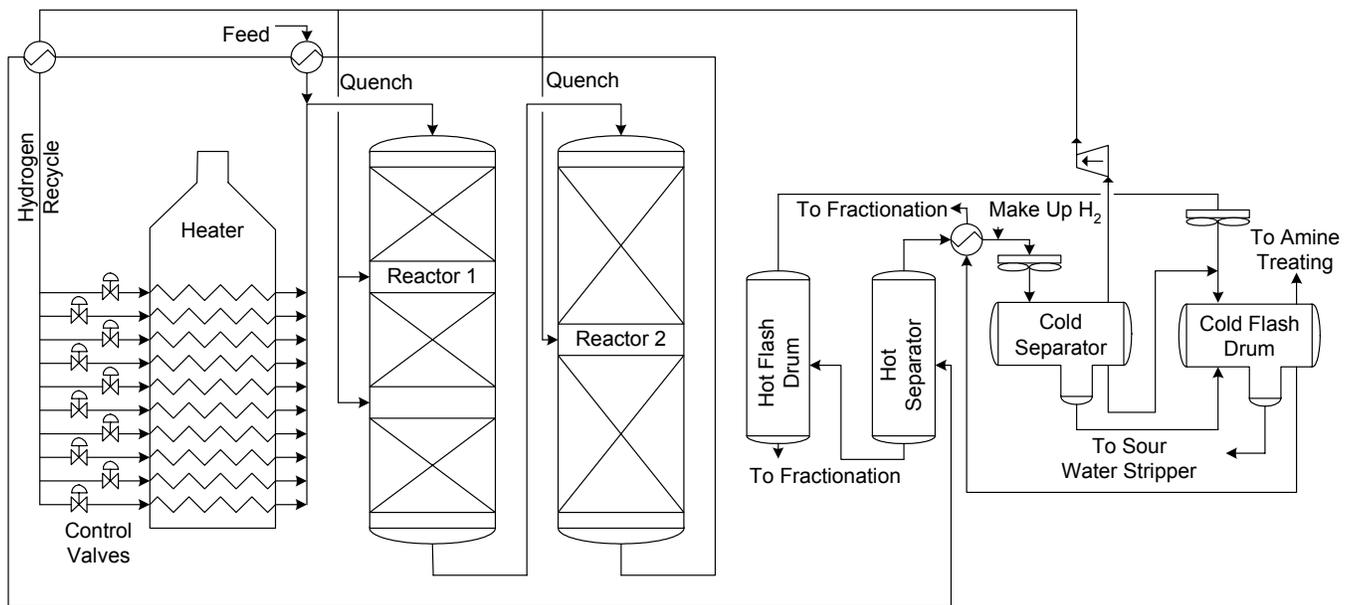
Figure 1 Diagram showing flow scheme for hydroprocessing unit and location of recycle gas heater control valves.

Following the commissioning of a new hydroprocessing unit at a Middle Eastern refinery in July 2001, seizures of control valves for the recycle gas heater were reported in January, April, and June of 2002. On stream time between the January, April, and June failures was about 60 days in each case. No abnormal operating conditions were reported during these periods. Figure 1 is a diagram showing the general arrangement of the unit and the location of the valve bank. The normal recycle gas stream is composed of 90% hydrogen, 3 – 4% hydrogen sulfide and 6 – 7% light hydrocarbon. The normal operating pressure and temperature of the recycle gas stream at the location of the valve bank were 17.25 MPa (2500 psi) and 400° C (752° F) respectively.

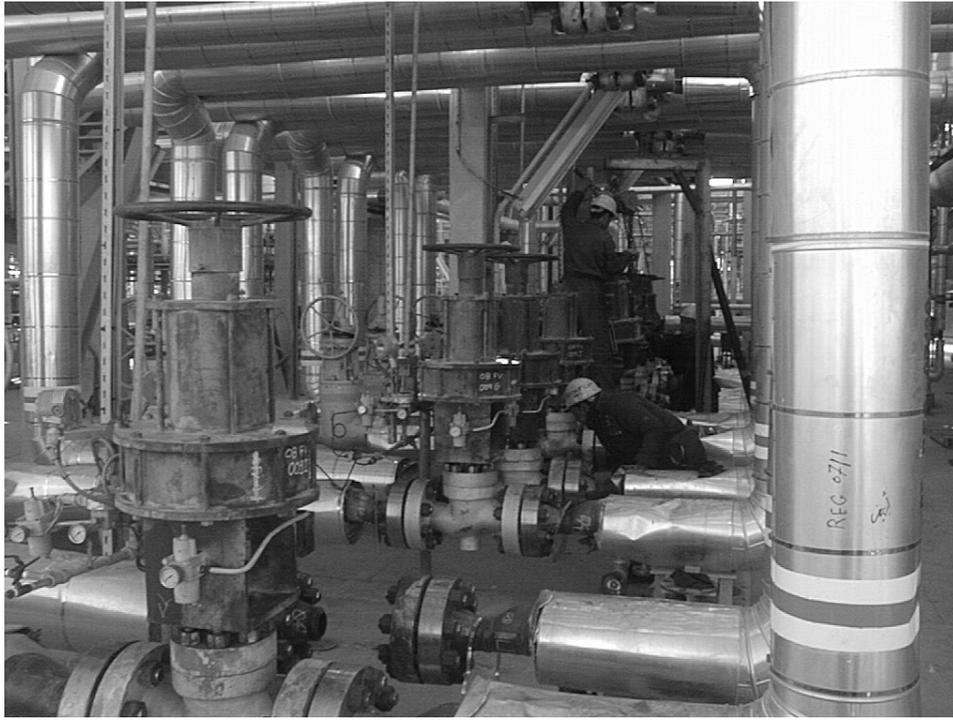
Figure 2 Photo of valves.

The valve bank, shown in Figure 2, consisted of ten - 10 cm (4 inch), balanced, plug and cage valves, mounted in parallel. The purpose of the valves was to ensure uniform flow distribution to the ten heater passes. Seizure of the valves resulted in the inability of the refinery to balance the flow between heater passes and created the potential for maldistribution of flow within the furnace. The refinery was, however, able to operate the unit for some time at full capacity following the seizures. The valves were

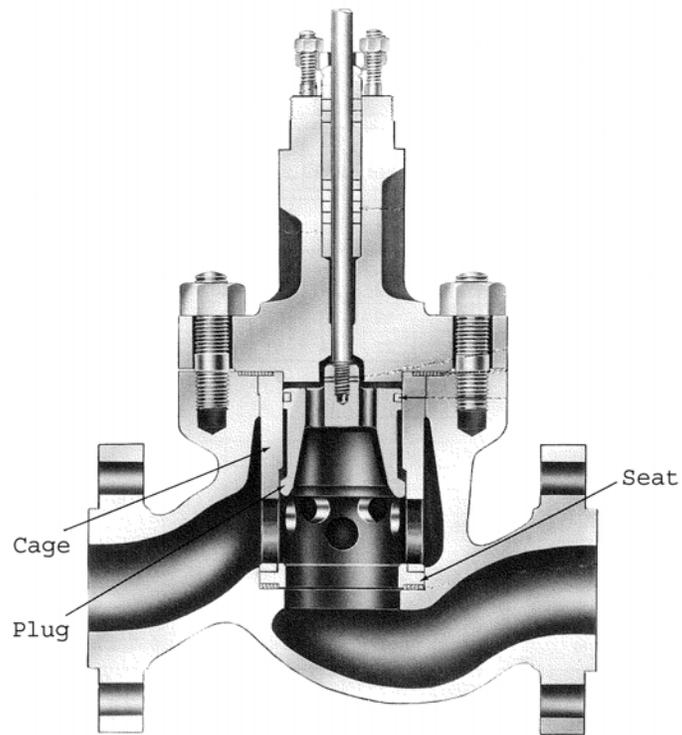
Figure 3 Control valve cross section.

designed for automatic control but were often controlled manually. Figure 3 is a cross section of the valves showing the valve body, the trim (plug and cage) and the seat. The recycle stream enters the valve from the left, passes through the holes in the cage into the center of the cage and then exits the valve to the right. Throttling of the flow is accomplished through up and down movement of the plug which covers or exposes the holes. The plug has holes in its upper surface which allow gases to pass to and from a dead space under the valve bonnet. This ensures that pressures on both sides of the plug are equal and minimizes the forces required to move the plug.

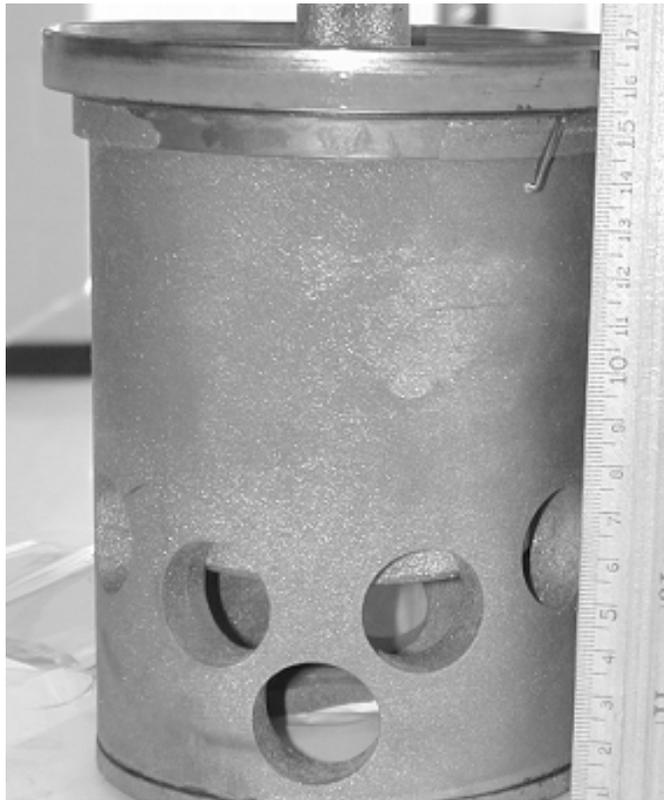
Figure 4 Typical valve trim. Seat is visible at the bottom of the trim. Plug is visible through holes in cage.

Figure 4 shows a typical valve trim as received. There was some variation in the hole pattern and construction of the trims examined; however, these differences were not significant to the seizure of the valves or the resolution of this problem. The valve seat may be seen at the bottom of the trim, and the bottom of the plug may be seen through the holes in the cage. Significant amounts of gray scale are present on most surfaces of the plug and cage. Some of the scale had a, faceted, crystalline appearance.

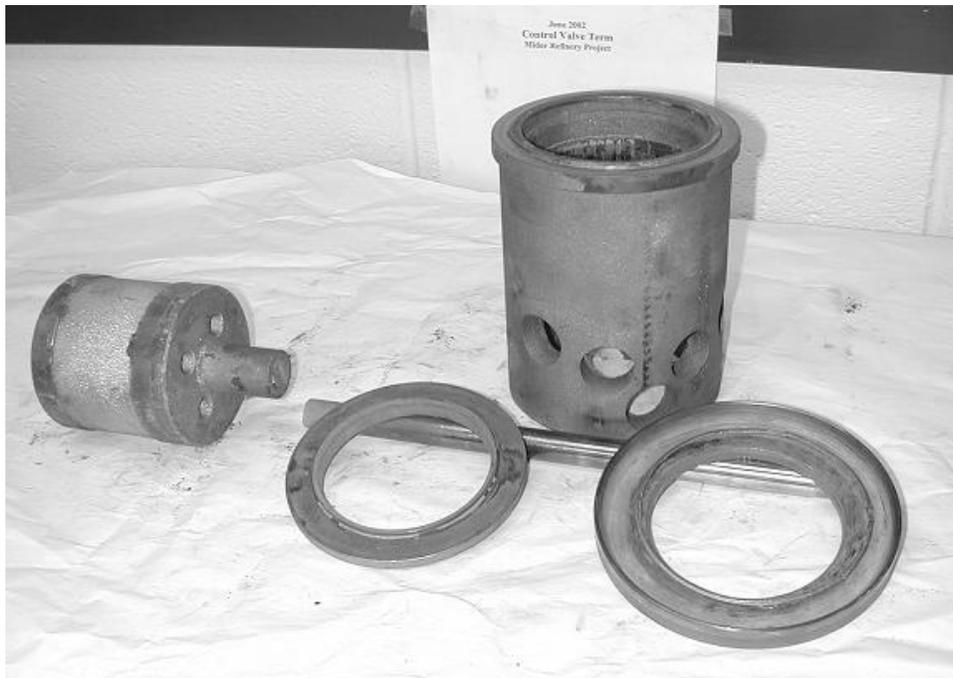
Figure 5 Typical valve trim following disassembly. Pressure equalization holes are visible in the top of the plug.

The process of disassembling the valve trims required the use of a great deal of force. Upon disassembly significant quantities of gray scale fell from the gap between the cage and the plug. This scale was similar in appearance to that observed on the outside of the cage. Figure 5 shows a typical trim following disassembly. Figure 6 shows a close up view of the plug. Scale thicknesses varied with location due to clearances within the valve but are 2 – 3 mm thick at the location shown by the arrow.

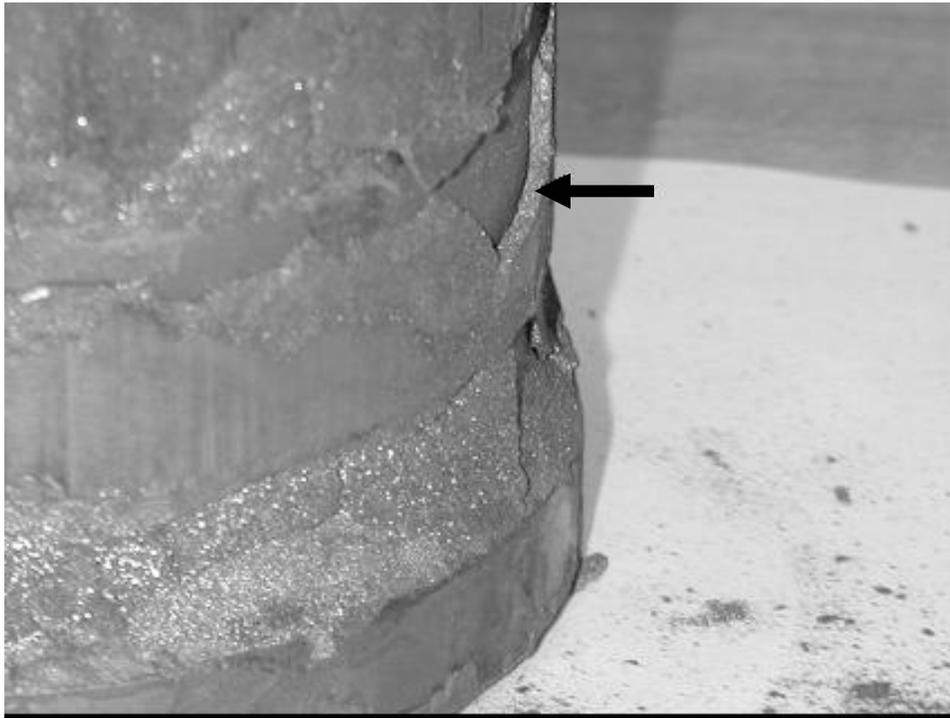
Figure 6 Close-up view of plug. Scale spalled in several locations.
Scale thickness at arrow is 2 – 3 mm.

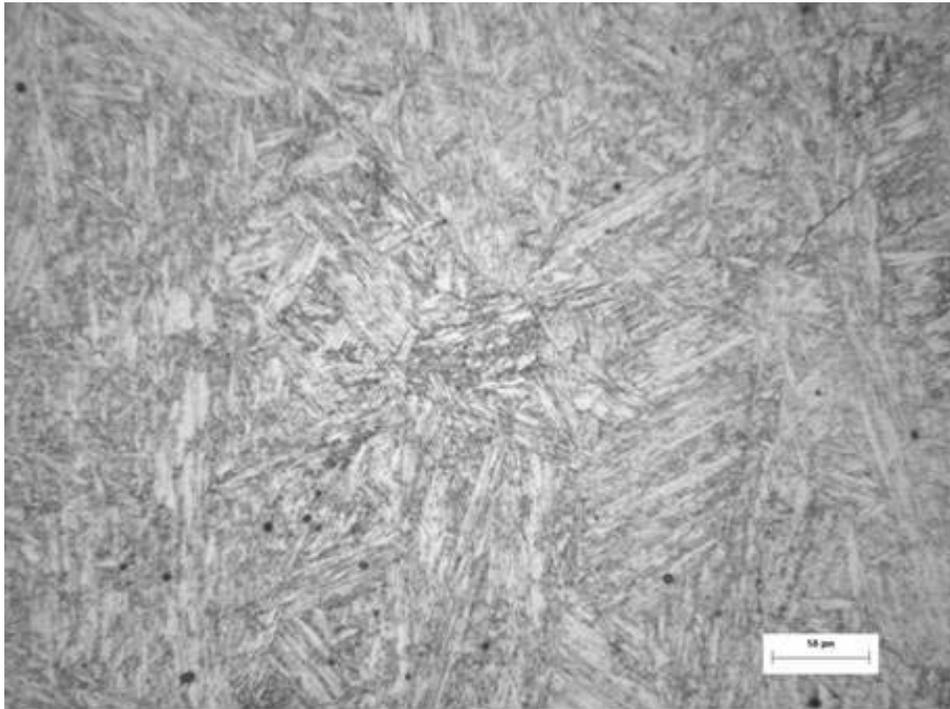
Figure 7 Micrograph of cage base metal showing martensitic structure.

Figure 7 is a micrograph showing the typical structure of the base metal of the plug and cage. The structure is martensitic as is expected for CA6NM material.

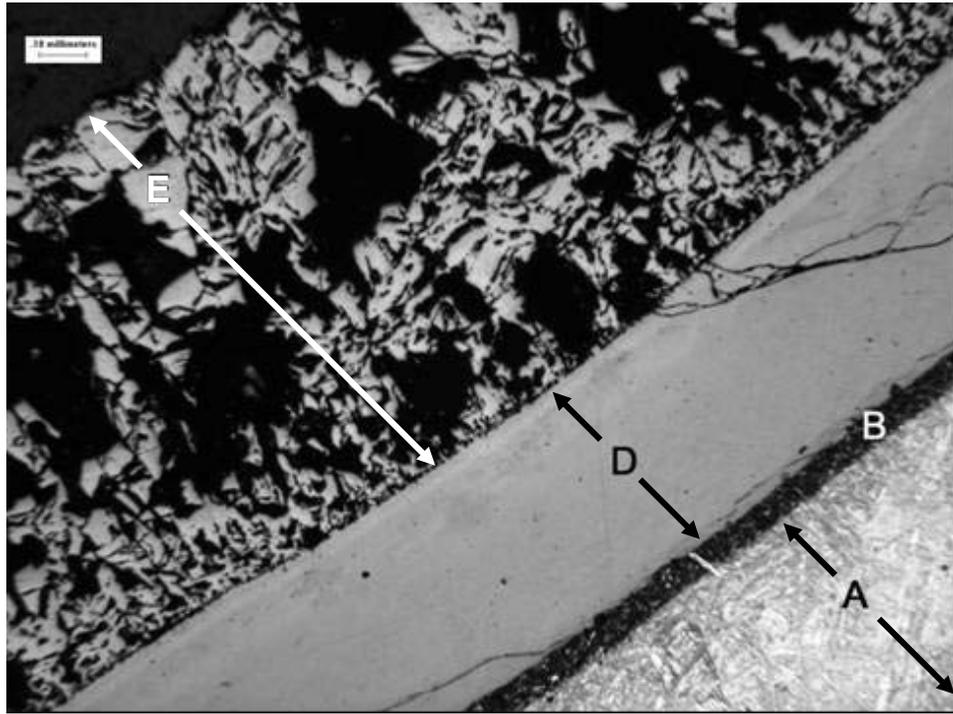
Figure 8 Micrograph of a typical surface region of the trim. “A” is martensitic base metal, “B” is the carburized layer, “D” is a Cr rich sulfide, “E” is an iron rich sulfide.

Figure 8 is a micrograph of a typical surface region of the trim. Base metal, as shown in Figure 7, is designated “A” in this figure. “B” is a dark band which was originally believed to be the nitrided layer, but as will be shown in the chemistry section below, proved to be a carburized layer. Again, as will be shown in the chemistry section below, layers D and E are chromium rich and iron rich sulfides respectively. Mounting media is visible in the upper left corner of the micrograph.

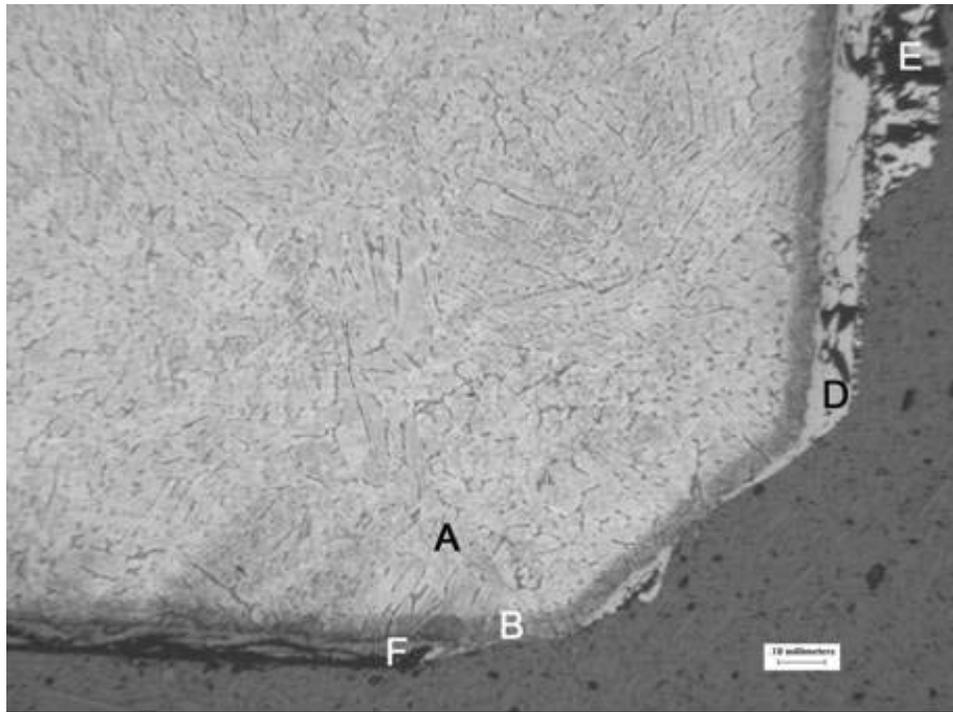
Figure 9 Micrograph of corner of cage. Right edge exposed to process. Bottom edge protected by seat. Symbols as identified in Figure 8. “F” is the nitride layer.

Figure 9 shows the corner of the cage where it meets the seat. The vertical portion of the cage at the right of the micrograph is exposed to the process environment. The horizontal portion of the cage at the bottom of the micrograph mates with the seat and is protected from the process environment. The microstructure of the base metal, labeled “A” in this Figure is different from that shown in Figure 7. The microstructure in this Figure is dendritic while that in Figure 7 is martensitic. Whether the final CA6NM casting appears martensitic or dendritic depends on a number of factors such as chemistry, cooling rate, and post casting heat treatments. It is not clear why the structure is different in two otherwise similar castings, however, the state of the base metal, martensitic or dendritic, did not contribute to the seizure of the valves. The inner and outer (chromium and iron rich) sulfide layers, labeled “D” and “E”, are visible in areas where the cage was exposed to the process environment (right side of micrograph) and absent where the cage was protected from the environment. The dark, carburized layer in this figure (“B”) is uniform in thickness regardless of the presence or absence of sulfide scales and is of similar thickness to the typical dark layer shown in Figure 8. An additional layer “F”, which is not present in Figure 8, is visible in this micrograph in locations protected from the process environment. As will be shown in Figure 10, hardness tests, and the chemical analyses section below, this is the nitrided layer.

Analytical results indicate that the dark layer (“B”) shown in Figure 9 is a carburized layer. Given that the operating temperature of the valves is too low to cause significant carburization, this layer must have formed in association with nitriding process. (It is unlikely that the carburized layer is an intentional result of the nitriding process as most nitriding processes such as ion nitriding and ammonia gas nitriding do not involve carbon. Carbon contamination on the surface of the part could account for the carburized layer.) As such, the thickness of this layer is expected to be equal at all locations on the part. Careful examination of Figure 9 indicates that, following exposure, the thickness of the carburized layer remains uniform irrespective of the presence or absence of the nitrided layer (“F”) or sulfide scales (“D” and “E”). The presence of the nitrided layer over the carburized layer at some locations indicates that the carburized layer has not been corroded in these locations. The uniformity of the thickness of the carburized layer between locations where the nitrided layer is present and absent indicates that the carburized layer has not been corroded even in areas where the nitrided layer is absent. From this it may be inferred that the thickness of material corroded in areas from which the nitrided layer is absent is exactly equal to the thickness of the nitrided layer. The thickness of the nitrided layer was specified to be 0.15 mm. The corrosion rate resulting from the loss of 0.15 mm in two months of service is 0.9 mm/yr (35 mpy).

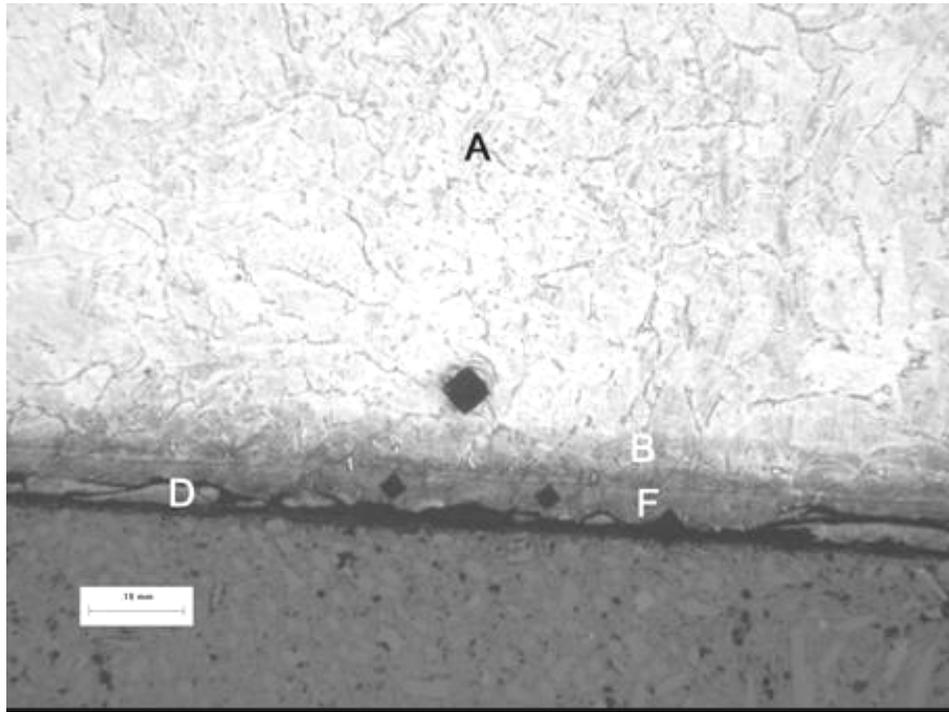
Figure 10 Vickers microhardness indents showing the variation in hardness between the base metal “A” and the nitrided layer “F”.

Figure 10 is a micrograph showing the results of microhardness testing (Vickers 500 g load). As in previous micrographs, “A” represents base metal (dendritic in this case); “B” represents the carburized layer; “F” represents the nitrided layer; and “D” represents the chromium rich sulfide layer. Hardness values for the various layers may be found in Table 1. All hardness values were within the expected ranges.

Table 1 Vickers microhardness values (500g load).
Letter designations refer to Figure 10

Letter Designation	Layer Composition	Hardness (HV)
A	CA6NM Base Metal	353 - 380
B	Carburized Layer	380 - 419
F	Nitrided Layer	1080

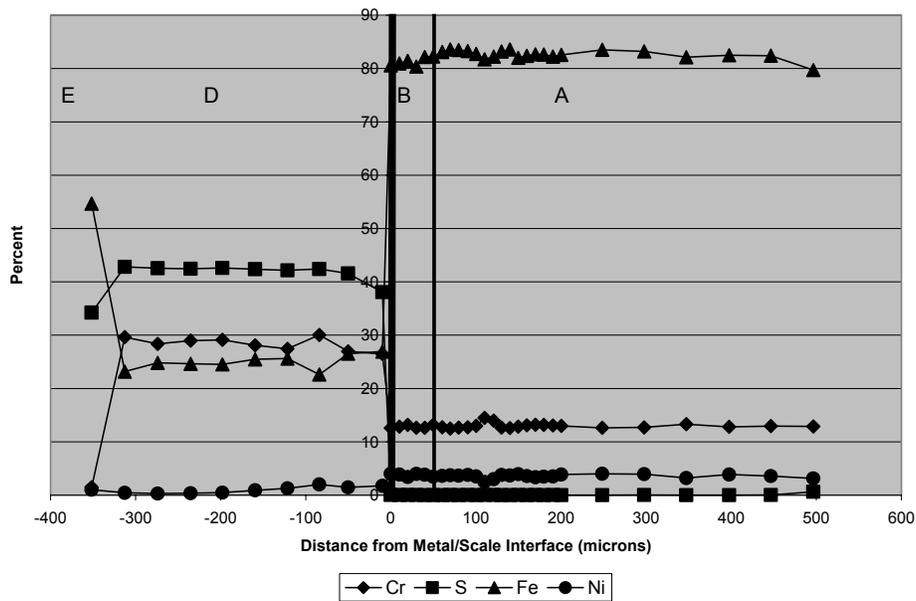
Figure 11 Variation in chemical composition with distance. Letters refer to bands as in previous Figures.

Figure 11 shows the variation in chemical composition of nickel, chromium, iron and sulfur for the scale and near surface based metal at a location where the nitrided layer was not present. This figure indicates that the outer layer “E” is an iron rich metal sulfide and that the inner layer of scale “D” is a chromium rich metal sulfide. This scale configuration (composition and layer structure) is typical of sulfide scales formed at high temperature hydrogen sulfide environments.

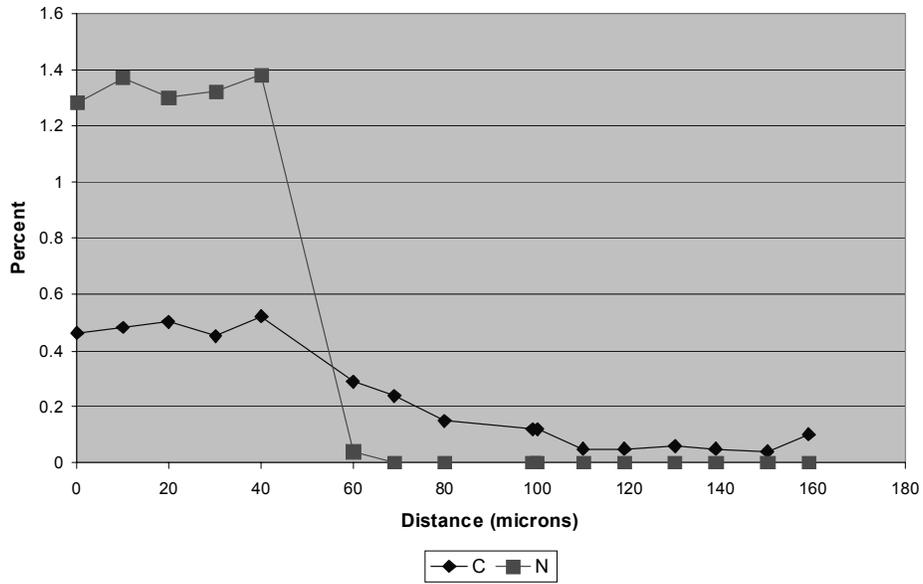
Figure 12 Variation of carbon and nitrogen through the nitrated layer.

Figure 12 shows the variation in carbon and nitrogen through the nitrided layer (“F”). This Figure shows that the region of increased nitrogen is very well defined and is in the location indicated by Figure 8. It also shows that there is some increase in carbon associated with the nitrided layer but that the carbon concentration is not solely related to the nitride layer, i.e., the variability in carbon concentration is much less distinct than the variation in nitrogen concentration.

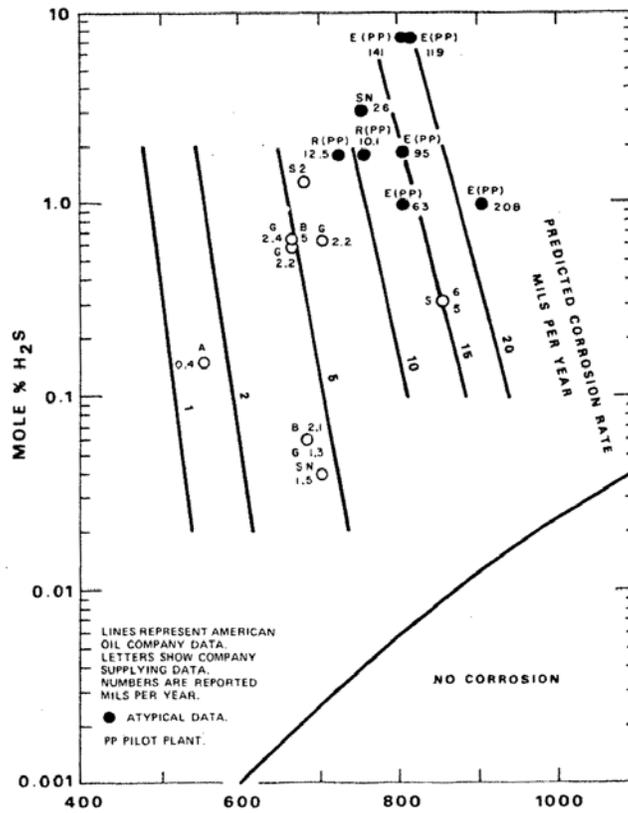
Figure 13 Couper-Gorman curve, 12 Cr stainless steel.²

The basis used for the selection of nitrided CA6NM valve trim for this service is not clear. There is some evidence that the material and surface treatment were selected based on their inclusion in MR0175-98 despite the fact that MR0175-98 is applicable only to sulfide stress cracking (not corrosion) in aqueous environments (paragraphs 1.1 – 1.3).¹ If predicted corrosion rates formed the basis for selection, it is probable that the Couper-Gorman curves² (Figure 13) for the corrosion of 12% chromium steels in H₂/H₂S service were used. These curves predict a corrosion rate of 0.3 mm/yr (11 mpy) for this service (3 – 4% H₂S at 400°C [752°F]).

The close agreement between the corrosion rate calculated from the loss of the nitrated layer (0.9 mm/yr [35 mpy]) and that calculated from scale thickness (0.84 mpy [33 mpy]) and the large difference between these values and the corrosion rate predicted by the Couper-Gorman curves (0.3 mm/yr [11 mpy]) makes it highly unlikely that observed difference in the values is due to statistical or measurement uncertainty. A difference in the corrosion of CA6NM, as predicted by the Couper-Gorman curves and nitrated CA6NM, as measured in this study, must be determined.

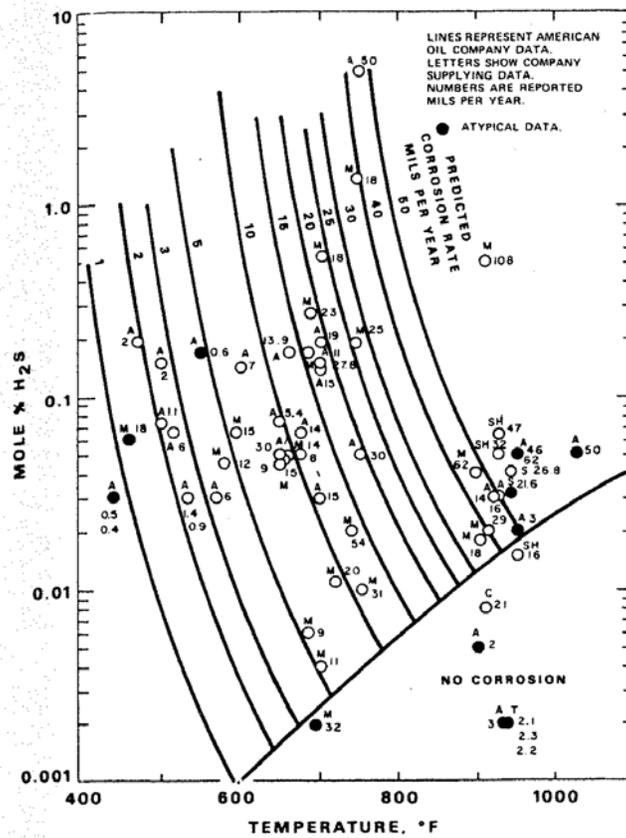
Figure 14 Coper-Gorman curve, 0 – 5 Cr steels.²

1. The seizure of the control valves was caused by the accumulation of corrosion deposits.
2. The corrosion rate experienced by the nitrated layer was in line with that which would be predicted by the Couper-Gorman curve for 0 – 5 Cr steel and much higher than would be predicted for 12 Cr steel.
