FAILURE OF UNS N10276 REACTOR IN SUPERCRITICAL WATER SERVICE

D. W. Alley, S. A. Bradley
UOP
25 E. Algonquin Rd.
Des Plaines IL 60017

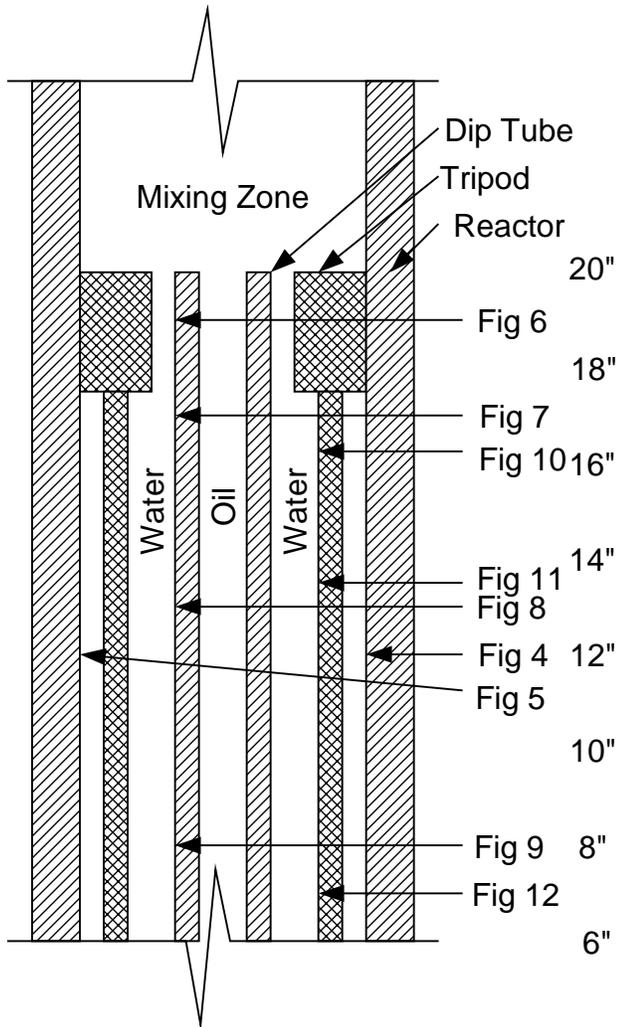
As is shown in Figure 1, oil enters from the bottom of the reactor within the dip tube. Oil pressure at this point exceeds the critical pressure of water but the temperature does not. The exact critical temperature and pressure for the oil and oil water mixture were not determined. Water also enters the reactor from the bottom in the annular space surrounding the dip tube. It also has sufficient pressure but insufficient temperature to be supercritical. As the water and oil travel up the dip tube and the annular space they acquire heat from the reactor's external heat source. The exact temperature profile is not known in this section of the reactor. It is known that the temperature exceeds that which is necessary to form supercritical water at some point prior to the mixing zone, based on readings from a thermocouple in the mixing zone.

Figure 1 Schematic drawing of reactor and internals. Reactor, dip tube, and thermowell are alloy 276. Tripod is type 316 stainless steel
